Monks Mound Updates: Long-Awaited Projects on Monks Mound to be Completed Summer 1998

BY BILL ISEMINGER—EXTRACTED FROM THE SUMMER 1997 CAHOKIAN

SIUE Monks Mound Project: 1997-98 by Bill Iseminger

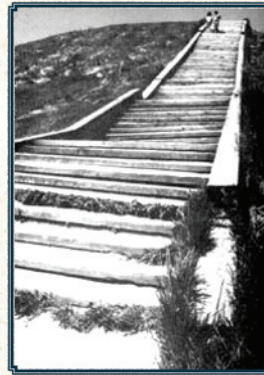
ORIGINAL WOODEN STEPS

Concrete steps, toned and textured with a central railing, are replacing the wood steps up Monks Mound. The wooden steps were initially installed during the early 1980s and repaired in the mid 1980s. Even though made of treated lumber, they have suffered from decay and splitting and have shifted and tilted in several areas, primarily due to erosion of the soil beneath the steps by rainwater washing through and beneath them. The stair project first involved archaeological investigations where support footings were poured, then the surface was contoured, stabilized, and the pre-cast concrete stairs set in place. These will be stronger, more stable, and the solid nature of the steps will prevent water from running through them.

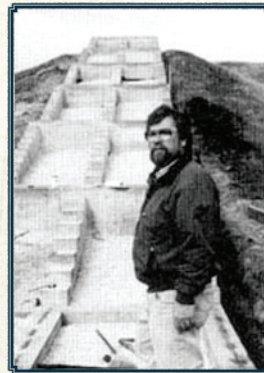
NEIL RANGEN, SITE MANAGER FOR CAHOKIA MOUNDS HISTORIC SITE, STANDING NEXT TO NEW STEPS UNDER CONSTRUCTION ON MONKS MOUND.
